**Flood Control Project Maintenance  
Levee Inspections**

**Fall 2012 Levee Maintenance Deficiency Summary Report**

**Reclamation District No. 2085 Kasson**

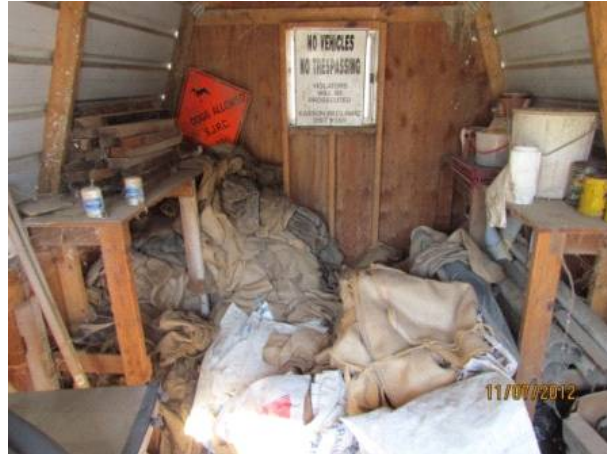
Levee Mile Report Line	3
Start Levee Mile	
End Levee Mile	
Location	Water Side
Category	Earthen Levee
Item	Emergency Supplies & Equipment

View of flood fight emergency supplies.

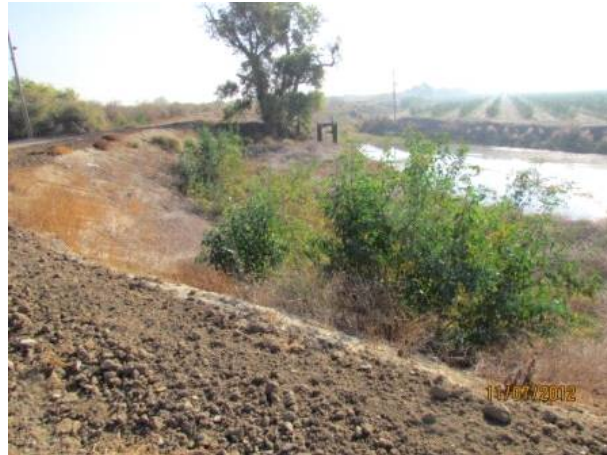
Levee Mile Report Line	4
Start Levee Mile	0.41
End Levee Mile	0.64
Location	Land Side
Category	Earthen Levee
Item	Vegetation

View of tall vegetation on landside slope obstructing visibility.

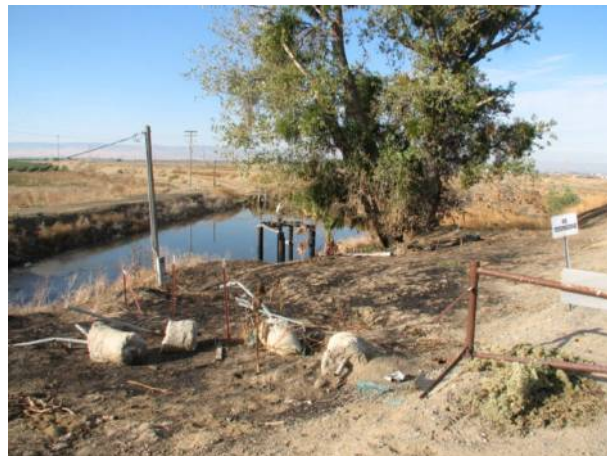
Levee Mile Report Line	5
Start Levee Mile	0.47
End Levee Mile	0.47
Location	Water Side
Category	Earthen Levee
Item	Encroachments

Drainage discharge pipe penetrates levee with no closure device.

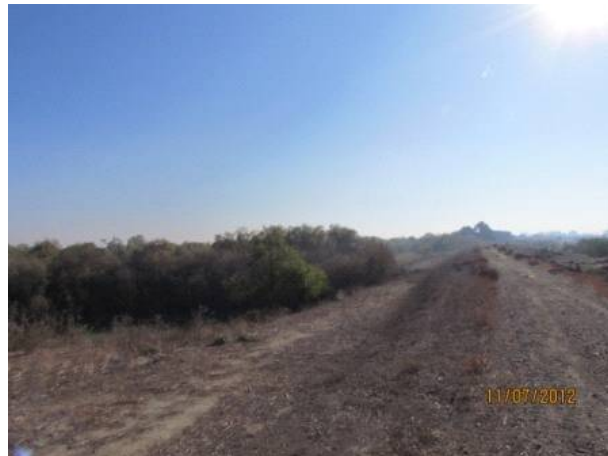
Levee Mile Report Line	6
Start Levee Mile	0.51
End Levee Mile	2.08
Location	Water Side
Category	Earthen Levee
Item	Vegetation

View of acceptable vegetation control on waterside slope.

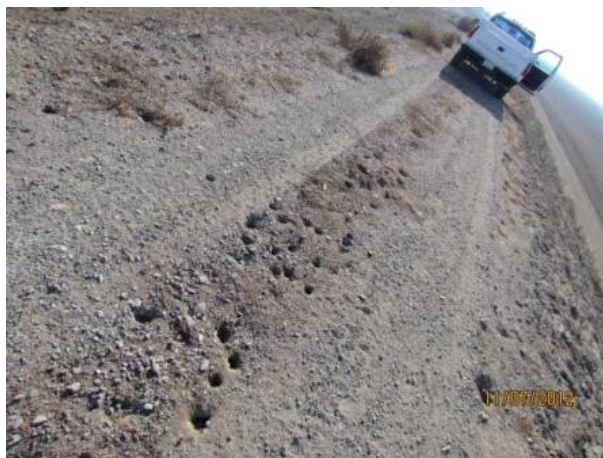
Levee Mile Report Line	8
Start Levee Mile	1.15
End Levee Mile	1.15
Location	Crown
Category	Earthen Levee
Item	Animal Control

View of multiple rodent burrows on levee crown.

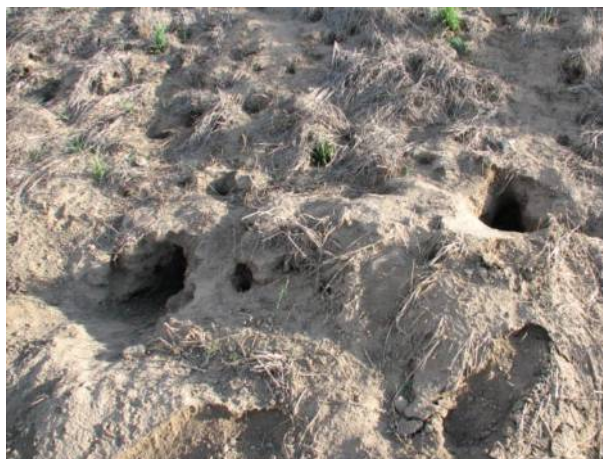
Levee Mile Report Line	9
Start Levee Mile	1.18
End Levee Mile	1.18
Location	Land Side
Category	Earthen Levee
Item	Animal Control

11/03/2011 Several burrows present.

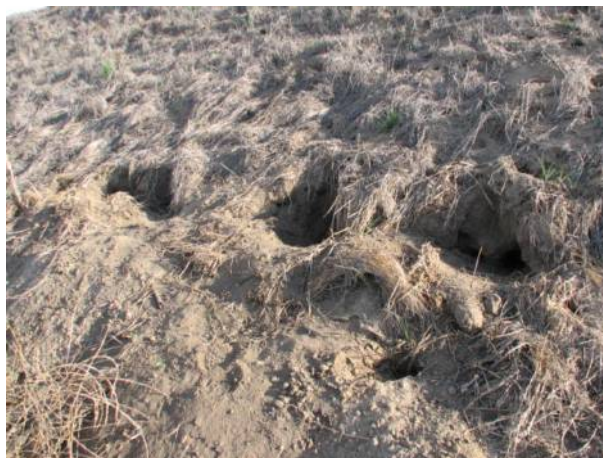
Levee Mile Report Line	9
Start Levee Mile	1.18
End Levee Mile	1.18
Location	Land Side
Category	Earthen Levee
Item	Animal Control

11/03/2011 Second photo more burrows in the same location.

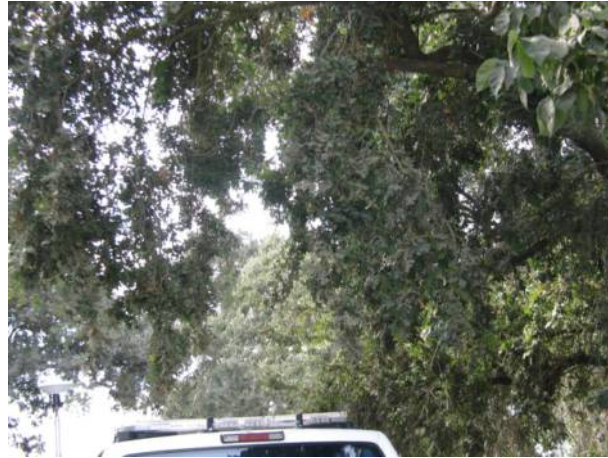
11/03/2011 Tree needs to be trimmed up to a minimum of 12' over the roadway.

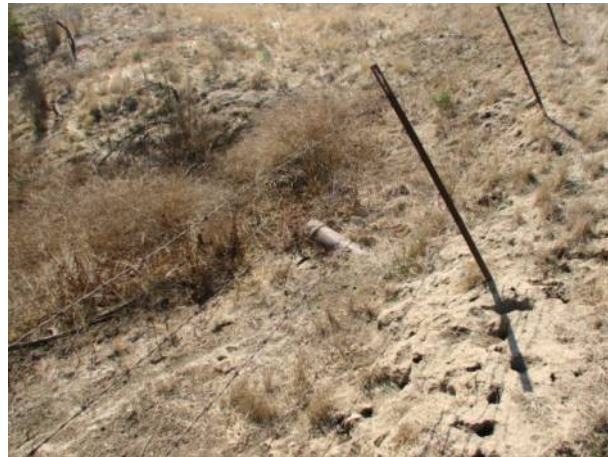
Levee Mile Report Line	20
Start Levee Mile	3.24
End Levee Mile	3.24
Location	Water Side
Category	Earthen Levee
Item	Encroachments

Photo of pipe penetration dishcharge off landside slope.

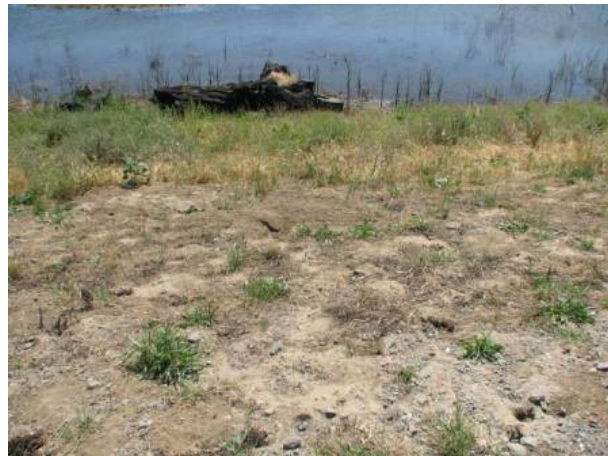
Levee Mile Report Line	21
Start Levee Mile	3.28
End Levee Mile	3.28
Location	Water Side
Category	Earthen Levee
Item	Animal Control

04/28/2011 Fresh burrow in center of picture, "porch" extends to the grass line.

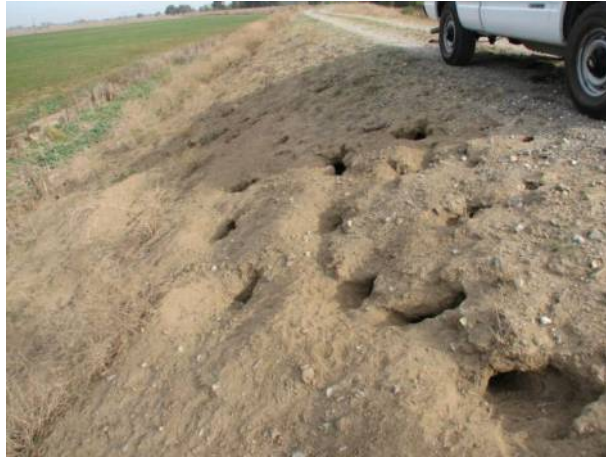
11/03/2011 Landside burrows.

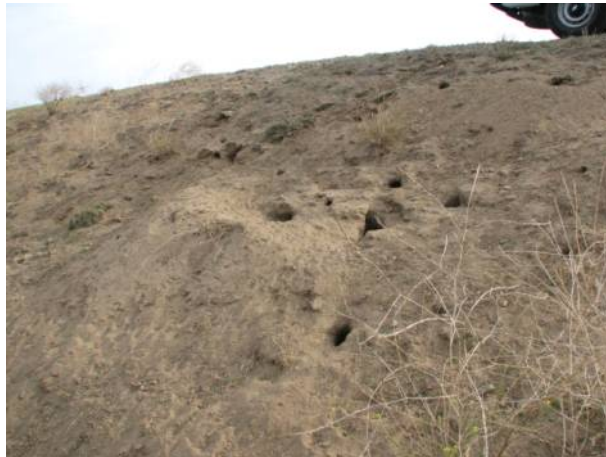
Levee Mile Report Line	22
Start Levee Mile	3.31
End Levee Mile	3.31
Location	Land Side
Category	Earthen Levee
Item	Animal Control

11/03/2011 More landside burrows at same location.

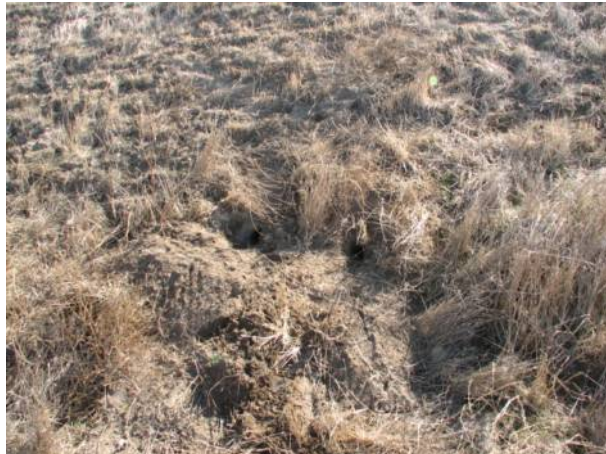
Levee Mile Report Line	25
Start Levee Mile	3.37
End Levee Mile	3.37
Location	Land Side
Category	Earthen Levee
Item	Animal Control

Rodent holes have been flagged for repair.

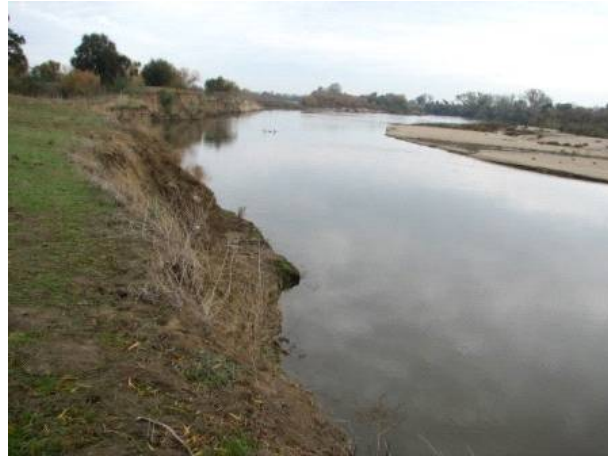
Looking downstream. At the downstream end the erosion occurring at a spur levee.

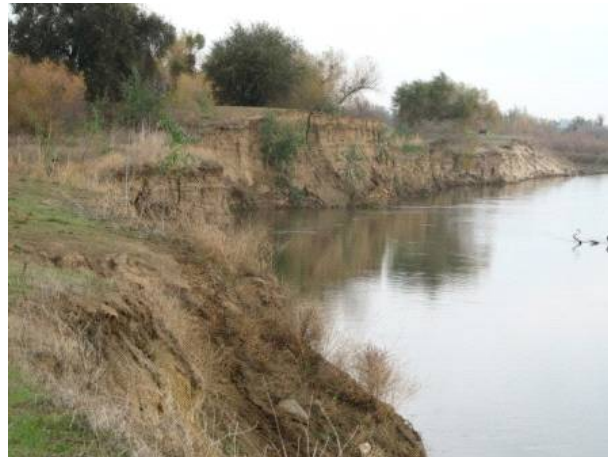
Levee Mile Report Line	28
Start Levee Mile	3.58
End Levee Mile	3.71
Location	Water Side
Category	Supplemental
Item	DWR Erosion Survey

Looking downstream at the erosion at the spur levee

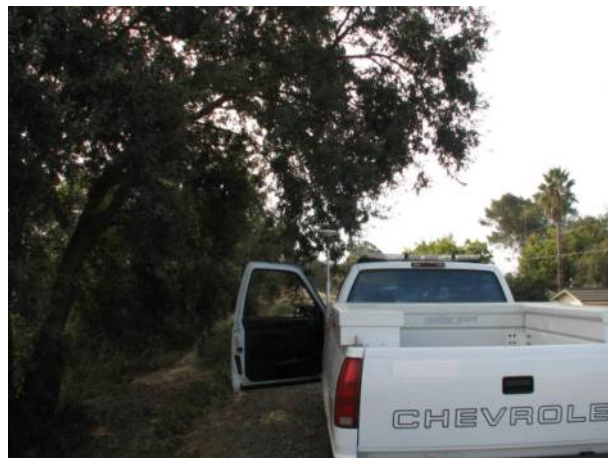
Levee Mile Report Line	33
Start Levee Mile	3.78
End Levee Mile	3.78
Location	Crown
Category	Earthen Levee
Item	Trim / Thin Trees

11/03/2011 Tree needs to be trimmed up to a minimum of 12' over the roadway.

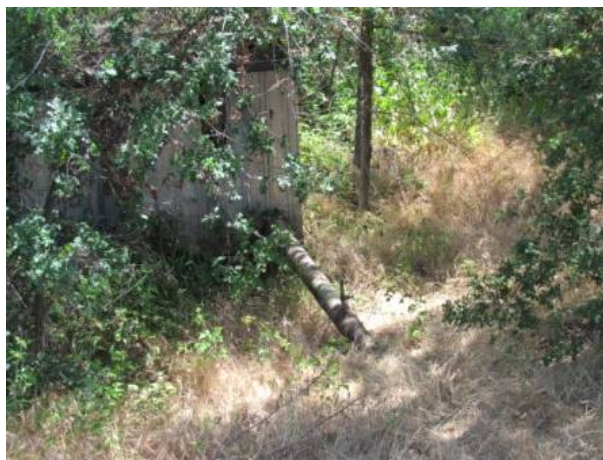
View of pipe penetrating waterside slope.  
05/16/2012

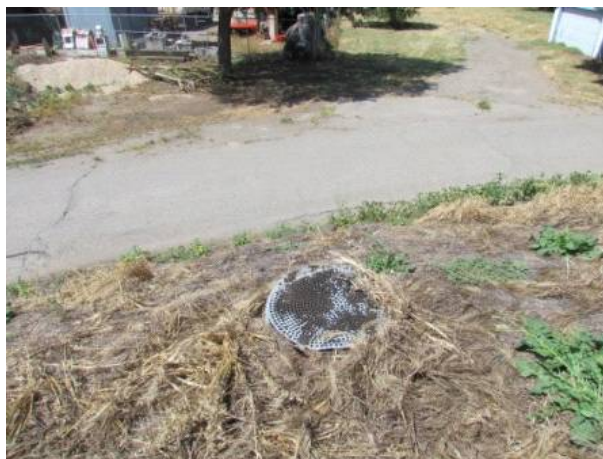
Levee Mile Report Line	35
Start Levee Mile	3.95
End Levee Mile	3.95
Location	Crown
Category	Earthen Levee
Item	Encroachments

View of siphon breaker valve on landside hinge.  
05/16/2012

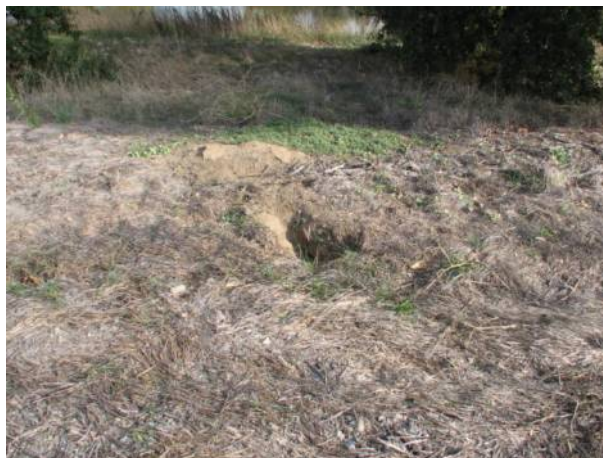
Levee Mile Report Line	36
Start Levee Mile	3.98
End Levee Mile	3.98
Location	Water Side
Category	Earthen Levee
Item	Animal Control

11/03/2011 Burrow on waterside.

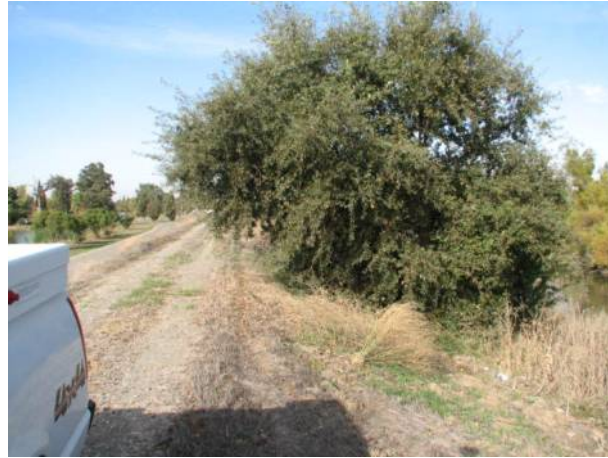
11/03/2011 Tree on waterside needs to be trimmed up 5' over slope and up to a minimum of 12' over the roadway.

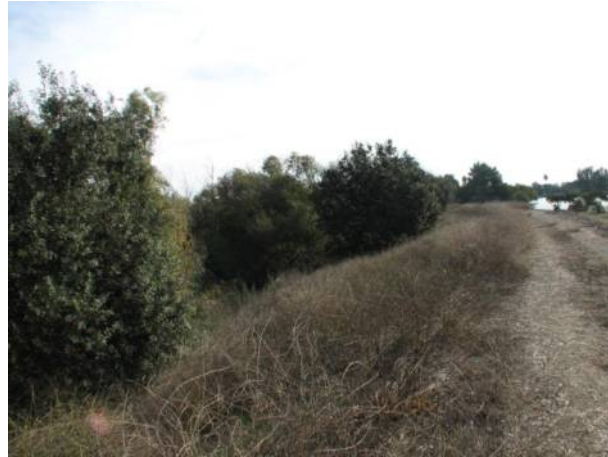
Levee Mile Report Line	38
Start Levee Mile	4.18
End Levee Mile	4.45
Location	Water Side
Category	Earthen Levee
Item	Vegetation

11/03/2011 Waterside vegetation needs to be maintained on the top 20' of the waterside slope.

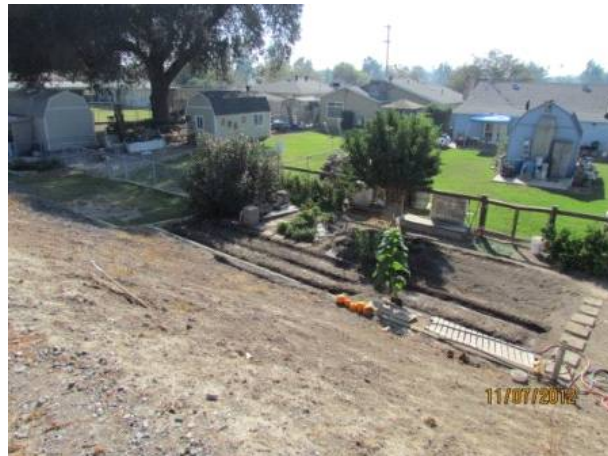
Levee Mile Report Line	41
Start Levee Mile	4.32
End Levee Mile	4.37
Location	Land Side
Category	Earthen Levee
Item	Vegetation

Updated photo of encroachments on landside toe.

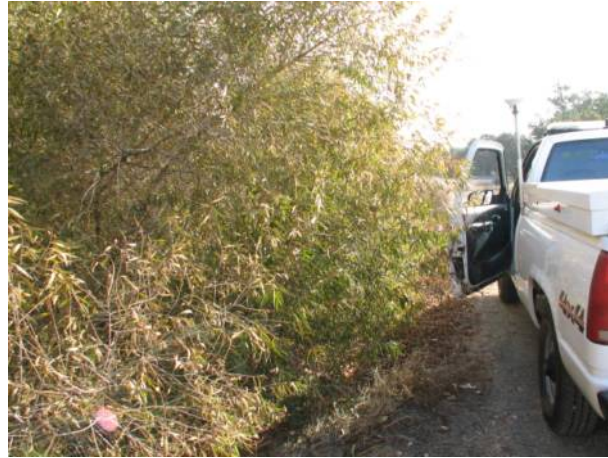
11/03/2011 Tree needs to be limbed up to 5' above the ground on the waterside for visibility.

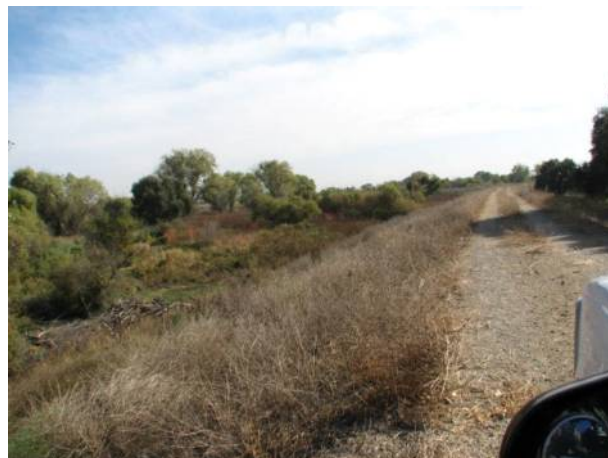
Levee Mile Report Line	44
Start Levee Mile	4.49
End Levee Mile	5.16
Location	Water Side
Category	Earthen Levee
Item	Vegetation

11/03/2011 Waterside vegetation needs to be managed on the top 20' of the slope.

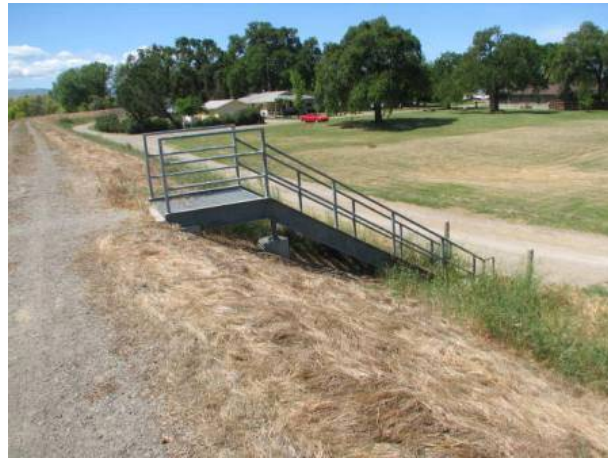
04/28/2011 Stairs on landside slope for monitoring station.

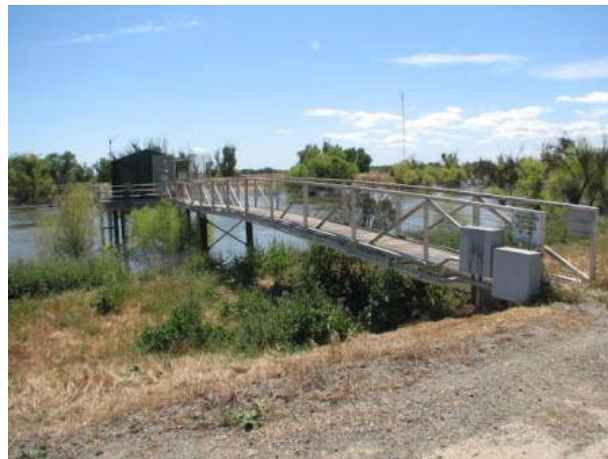
Levee Mile Report Line	47
Start Levee Mile	4.71
End Levee Mile	4.71
Location	Water Side
Category	Earthen Levee
Item	Encroachments

04/28/2011 Monitoring station.

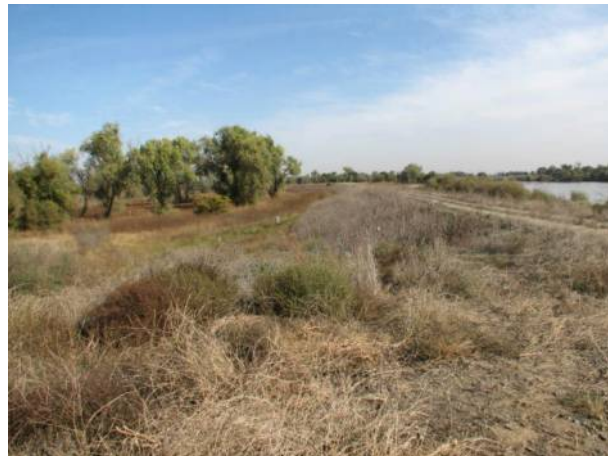
Levee Mile Report Line	48
Start Levee Mile	4.81
End Levee Mile	4.87
Location	Land Side
Category	Earthen Levee
Item	Vegetation

11/03/2011 Landside vegetation needs to be maintained for the full landside slope and 15' beyond the toe.

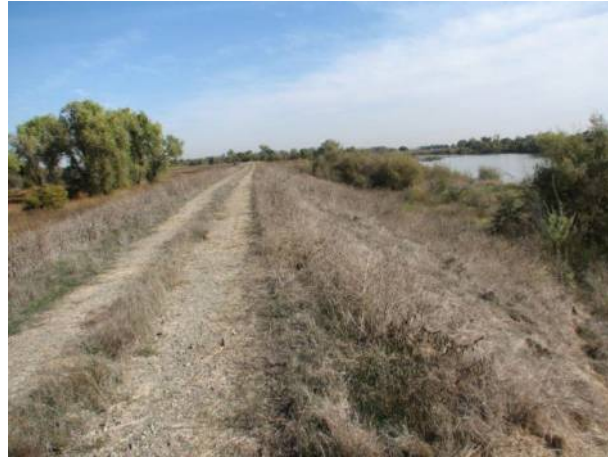
11/03/2011 Waterside vegetation has been sprayed, but needs to be removed so the top 20' of the slope is visible.

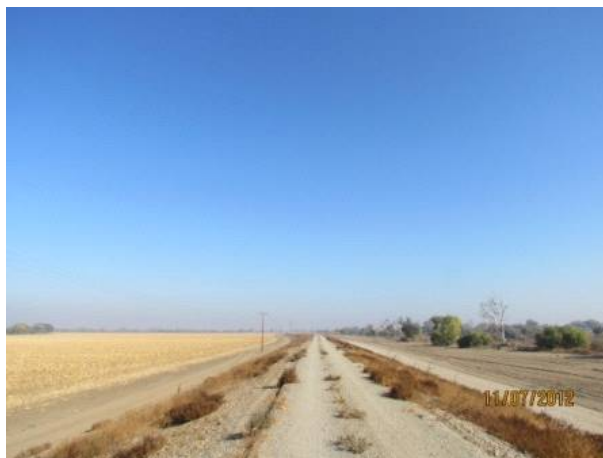
View of tall vegetation obstructing visibility of waterside slopes.

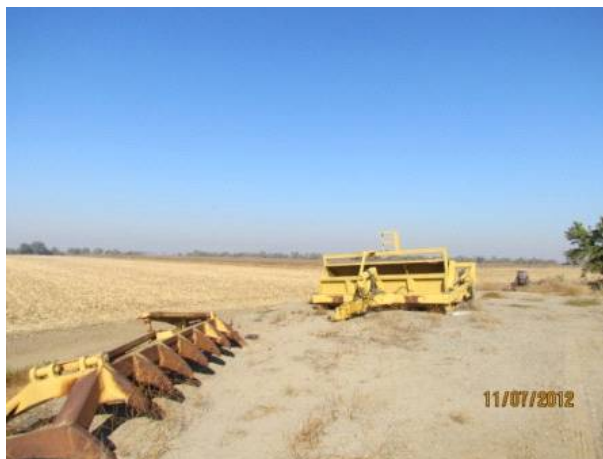
Levee Mile Report Line	2
Start Levee Mile	0.67
End Levee Mile	0.67
Location	Crown
Category	Earthen Levee
Item	Encroachments

View of farming equipment being stored on the levee crown at the end of the spur levee.

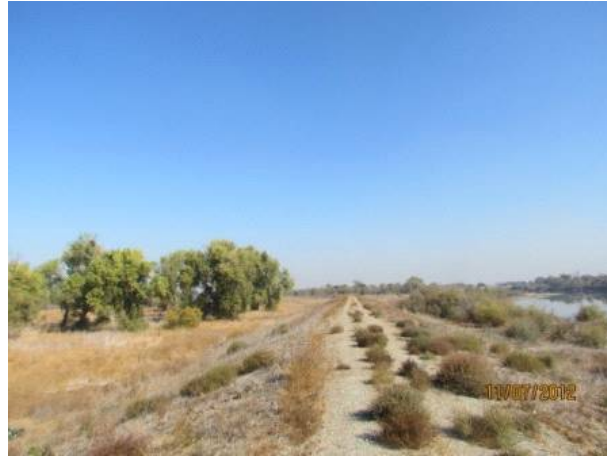
View of vegetation on waterside slope. Needs to be removed.
